## Skyview Communication Trouble Shooting

Follow the below troubleshooting steps when you are unable to communicate with your Skystream turbine. These procedures should be used when the turbine is still operating, yet there is no communication. If your turbine does not spin and you have no communication, contact your dealer or Southwest Windpower.

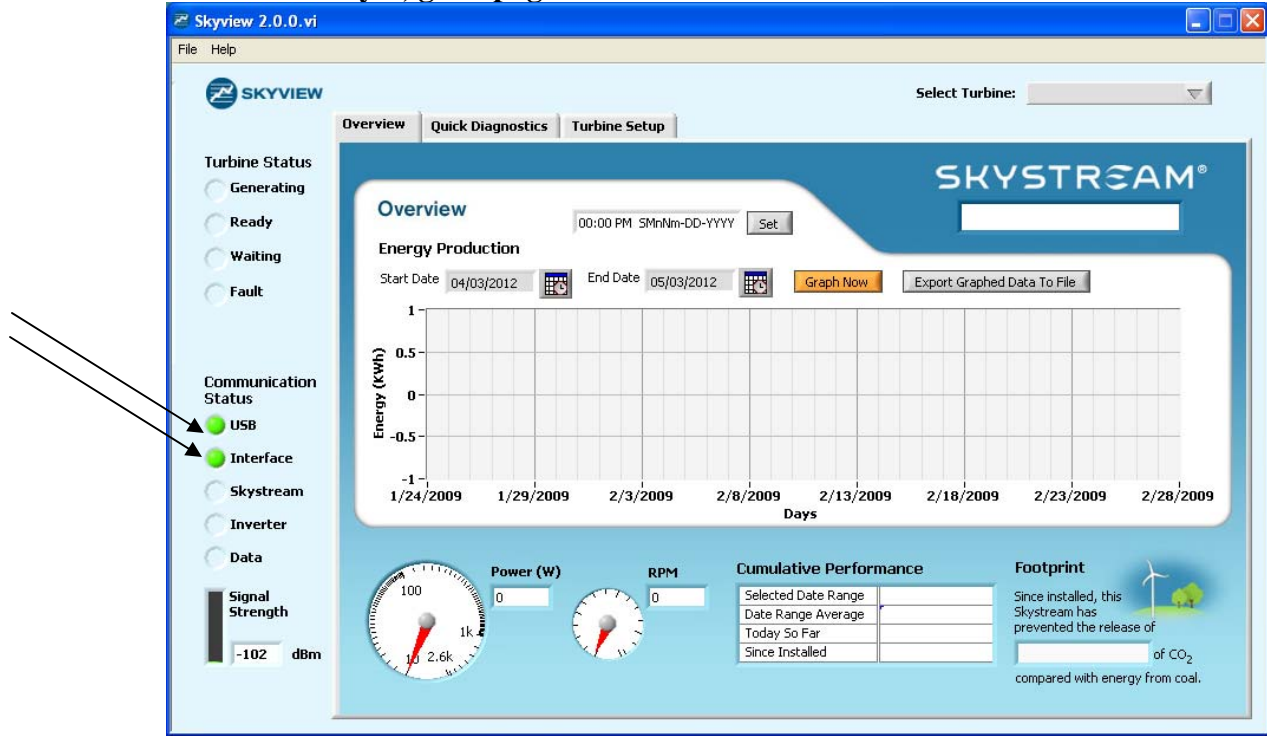
- ❖ **Communications Problem Type 1: Only the USB and Interface LED's illuminate? If yes, go to page 3.**

1. Confirm the antenna is still attached on top of the Skystream.
2. Ensure the USB Radio Receiver is working. There should be at least one light on.
3. Under the *Turbine Setup* tab, check if any entries appear under *Other Turbines Found*. If you find another entry confirm you have entered your serial number correctly.

- If it was incorrect, delete the old entry and re-enter the correct serial number. Perform step 5.
  - If it is correct, repeat step 5 first. If you have not established communication, call Southwest Windpower while you are on site. This number may or may not be related to your communications problem. Note: If you cannot call Southwest Windpower on site you should still continue with the communication troubleshooting steps.

4. Press the *Find Turbines* button, wait 60 seconds.
5. Go to *File* and select *Disconnect from USB Converter*. Wait 5 seconds. Go back to *File* and select *Connect to USB Converter*. Wait 60 seconds.

6. Move the USB cable to another port on your computer. Repeat step 5.
7. Change the line of sight. Move the computer next to a window, or move closer to the turbine (no closer than 30 feet), or step back at least 30 feet and repeat step 5.

8. Confirm the USB Radio Receiver is still in tact: ensure the top Xbee Pro Series 2 board is not separating or becoming “unseated” from the bottom board. If separating, open the box and carefully press the boards back together and repeat step 5.

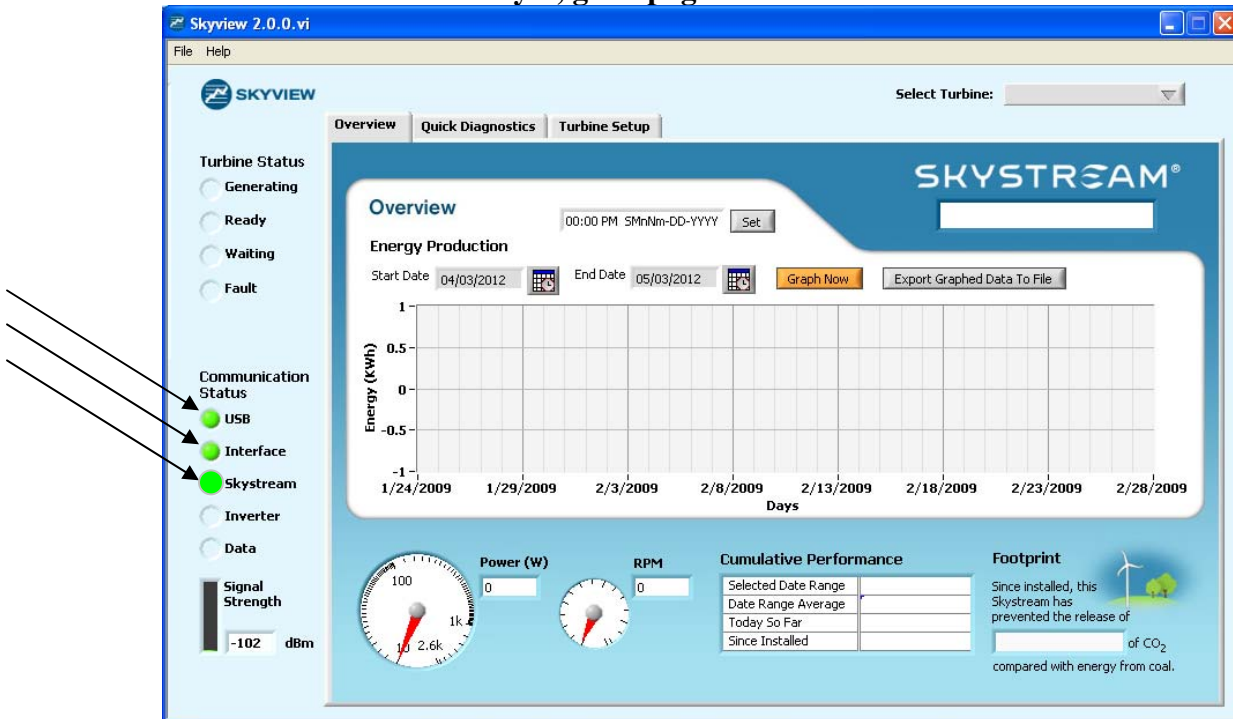
- ❖ **Communications Problem Type 2: Only the USB, Interface and Skystream LED's illuminate? If yes, go to page 5**

1. Shut power off to the turbine for 10 minutes. After 10 minutes turn power on to the turbine. If the same problem still persists you will have to download and run the zserfix.exe communications program.

2. To run the program, ensure your USB radio receiver is plugged in and **Skyview is closed**. Open zserfix.exe. It will look like this

3. Enter the last six digits of the serial number in the *Turbine ID* field, no dash, and select *Search*. Note: You may have to select *Search* several times before this works!

4. When zserfix.exe finds the turbine the *Turbine ID* field will change from 10#### to SKY37A\_1010#### (or SKY37A\_2010####)

5. Hit *Fix*. Below the Fix button you will receive a series of updates showing the progress of the program initialization and repair. Once the fix is complete the Status will indicate communication rate/speed has been fixed. Note: Sometimes this does not work the first time and you will have to hit the *Fix* button several times!
6. **Close zserfix.exe**. Open Skyview, and confirm all five Communication Status lights, USB, Interface, Skystream, Inverter and Data are on. (You may have to go to File and selection Disconnect from USB Converter, wait 5 seconds, go back to File and selection Connect to USB Converter). If they are not, contact Southwest Windpower.
7. If zserfix.exe has corrected the problem this may be only a temporary fix. We recommend checking communications intermittently for the next couple of days. If the Inverter and Data lights go out again contact Southwest Windpower.
